Inspector's Daily Report

•			
IDR Sheet	1	of	1	Sheets	Final Record Book	Page	
Contract	e.			Day	0	Date	
	C-785	2		N	Ionday	August 15, 2011

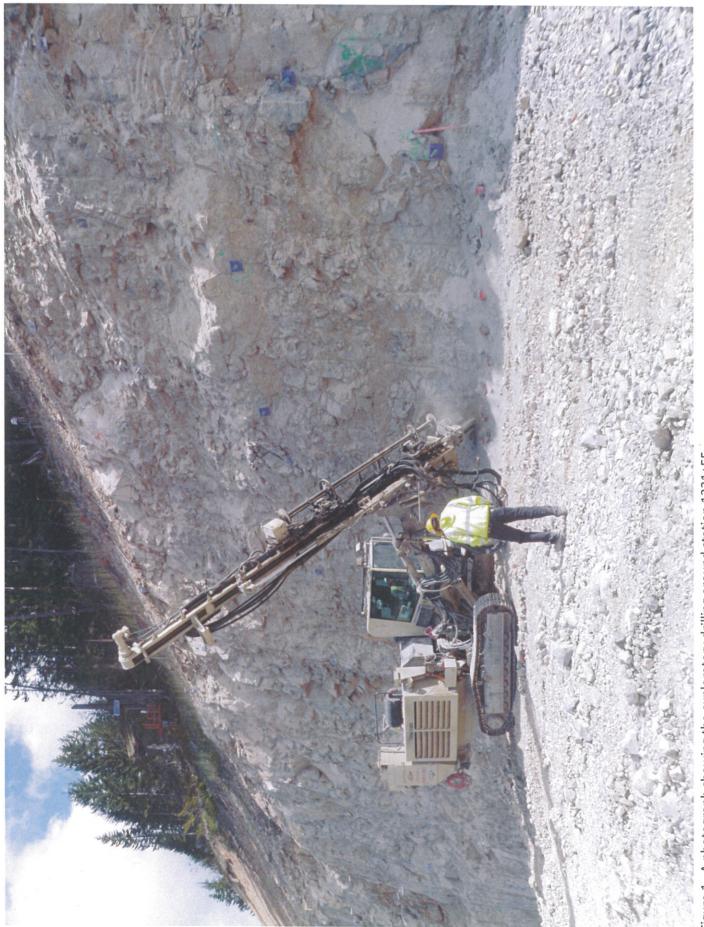
Figure 1. A photograph showing the exploratory drilling around station 1331+55.

I arrived on-site around 10:00 am and met Brad Schut on the west end of the project. Brad informed me about the conference call this morning and indicated that one of the topics discussed was about the pre-split holes drilled from approximate station 1331+50 to station 1333+00 that encountered an approximate 1.5 to 2.0 foot sand seam. I discussed this issue with Tom Badger and he requested that we have the contractor perform some exploratory drilling within these station limits in an attempt to verify the extent of the sand seam. We requested Western States to perform three borings at station 1331+55, 1331+85, and 1332+22 (Figure 1). All three borings were drill to a depth of 45 feet and at a 45 degree angle into the cutslope. Only the boring drilled at station 1331+55 encountered the sand seam approximately 30 to 31.5 feet deep (Figure 2). I relayed this information to Tom Badger and he indicated that we did not need anymore exploratory borings at this time; however, he would like copies of the production boring logs once the drilling is complete in this area.

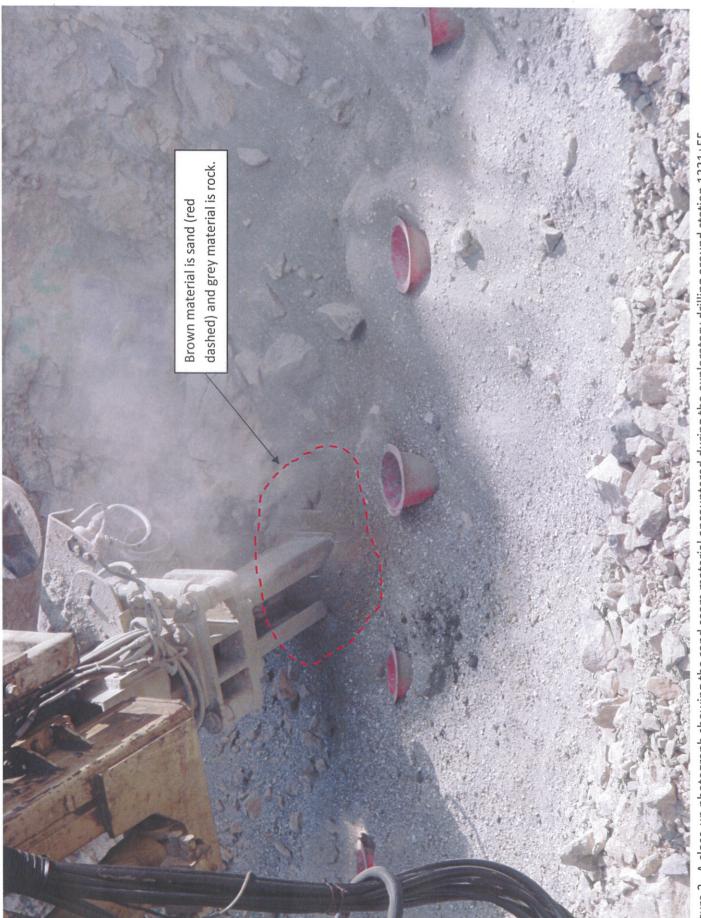
Figure 2. A close-up photograph showing the sand seam material encountered during the exploratory drilling around station 1331+55.

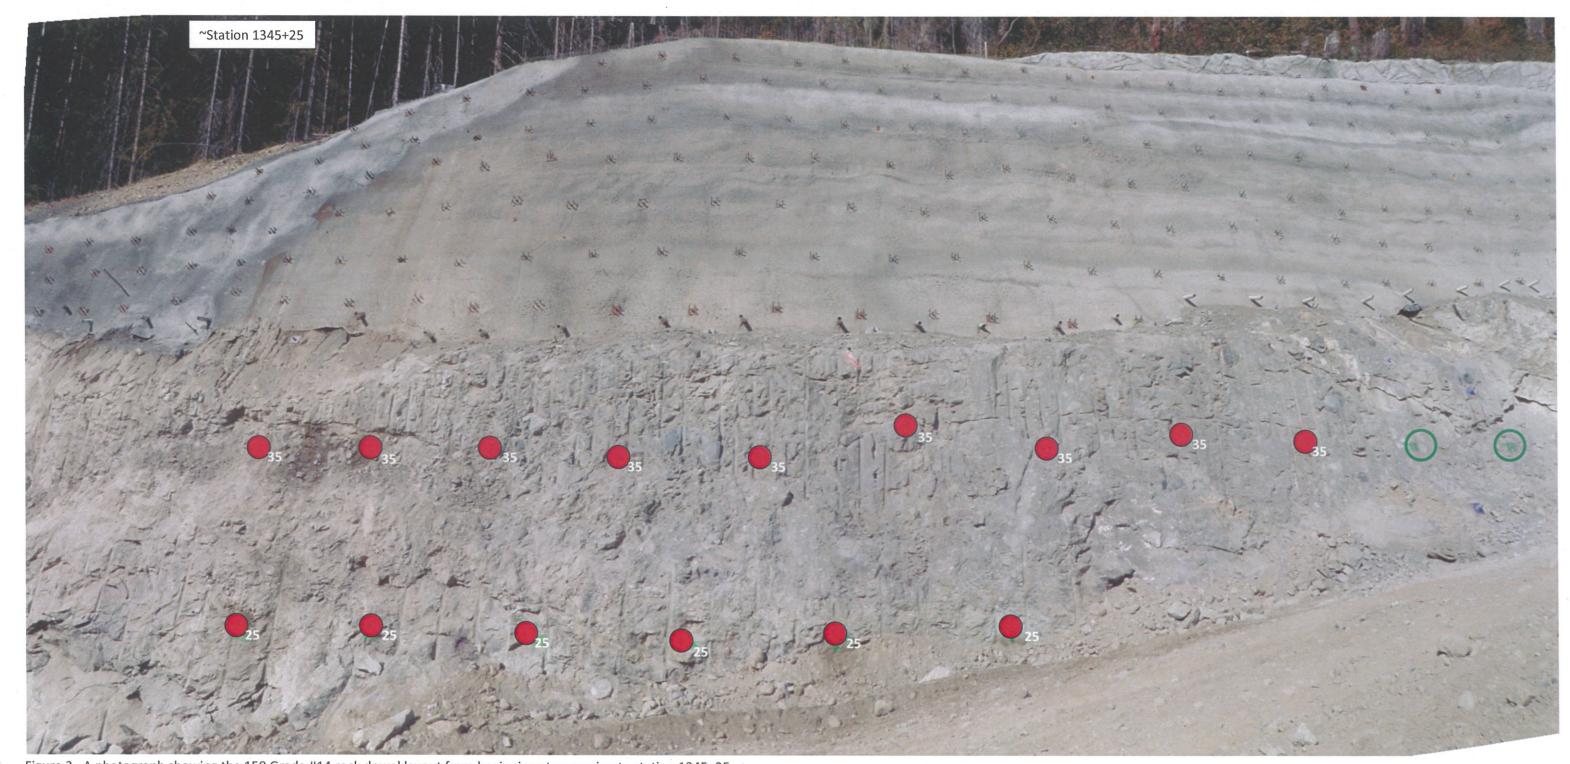
Figure 3. A photograph showing the 150 Grade #14 rock dowel layout from beginning at approximate station 1345+25.

35 - 150 Grade #14 Rock Dowels (Minimum Length in Feet)

Brad and I read through Norm Norrish's memorandum for the additional stabilization needed below the soil nail wall. We confirmed with Will Smith that we would extend two rows of the 150 grade, #14 rock dowels to the western limits of the soil nail wall. Brad and I laid out all of the rock dowels in the upper row (45 in all); however, we were only able to lay out 6 of the 9 lower row of rock dowels due to the existing ramp being in the way. The other 3 - 150 grade rock dowels, along with the lower row of type H rock dowels will need to be laid out once the bench is removed an additional lift. Brad indicated that he would email Northwest Cascade about the additional 150 grade #14 bars that will need to be ordered for the extension of the two rows we laid out.

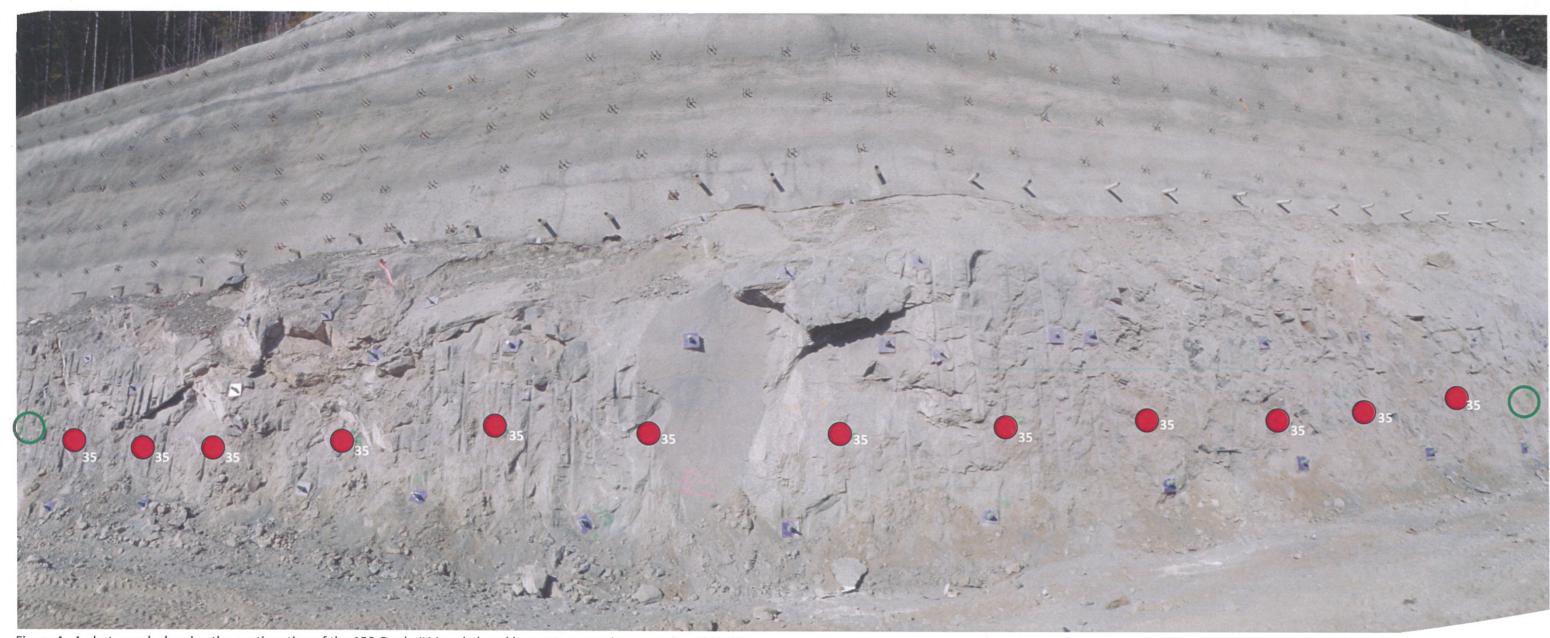
Figure 4. A photograph showing the continuation of the 150 Grade #14 rock dowel layout to approximate station 1349+00.

35 - 150 Grade #14 Rock Dowel (Minimum Length in Feet)

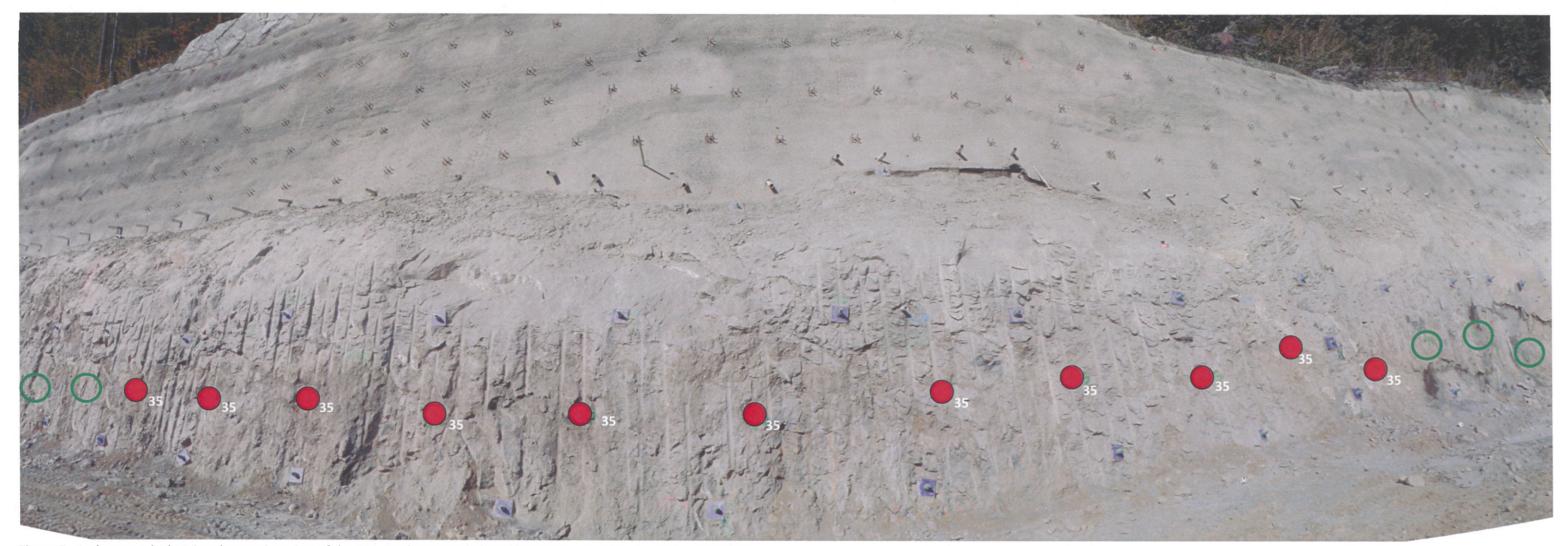
Figure 5. A photograph showing the continuation of the 150 Grade #14 rock dowel layout to approximate station 1349+00.

35 - 150 Grade #14 Rock Dowel (Minimum Length in Feet)

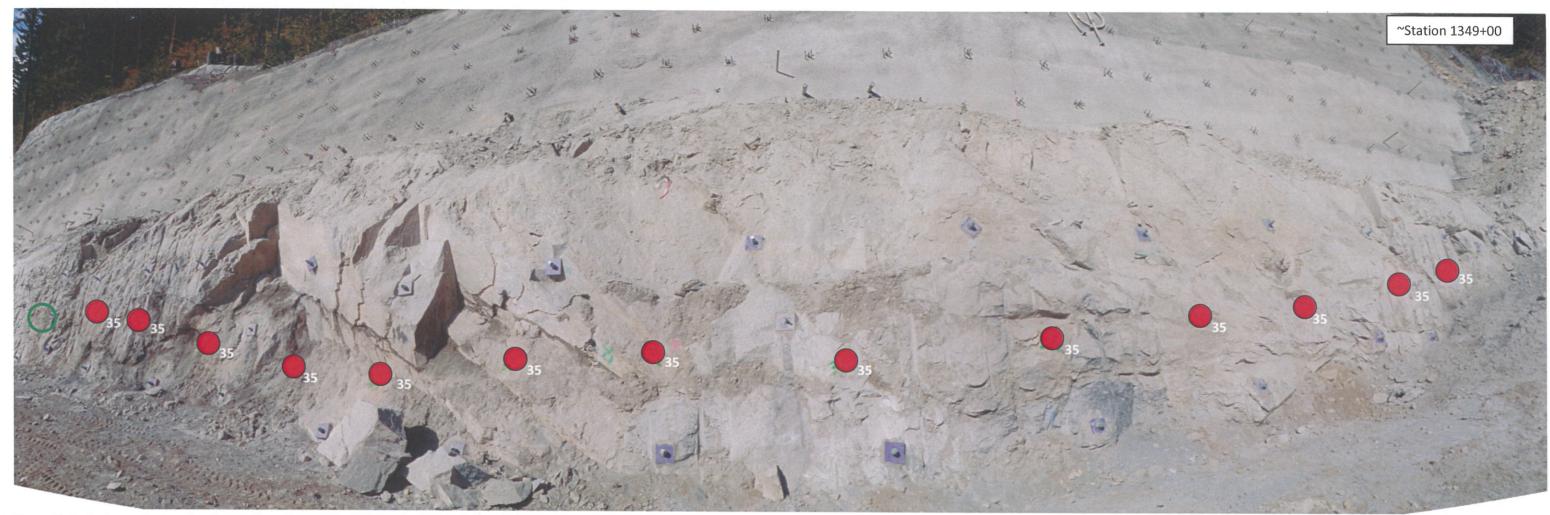
Figure 6. A photograph showing the continuation of the 150 Grade #14 rock dowel layout to approximate station 1349+00.

35 - 150 Grade #14 Rock Dowel (Minimum Length in Feet)
